**Flood Control Project Maintenance
Levee Inspections**

Fall 2013 Levee Maintenance Deficiency Summary Report

Reclamation District No. 1500 Sutter Basin

Waterway	Bank	Unit Miles
Unit No. 01 Sacramento River	Left	33.58

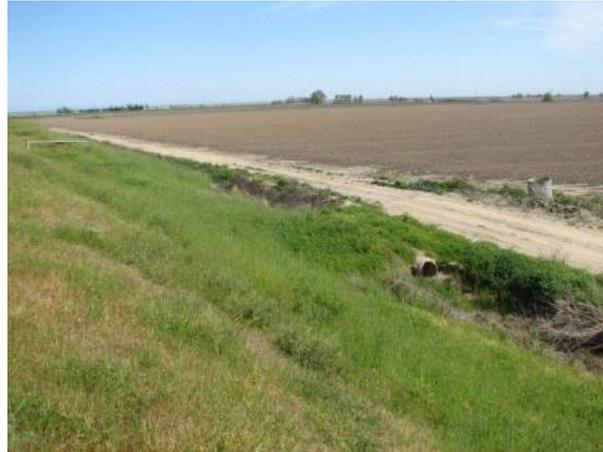
Levee Mile Report Line	86
Start Levee Mile	26.84
End Levee Mile	27.07
Location	Land Side
Category	Earthen Levee
Item	Encroachments
Agricultural ditch, photo taken in spring 2010.	
johngw_f_20130924_499.jpg

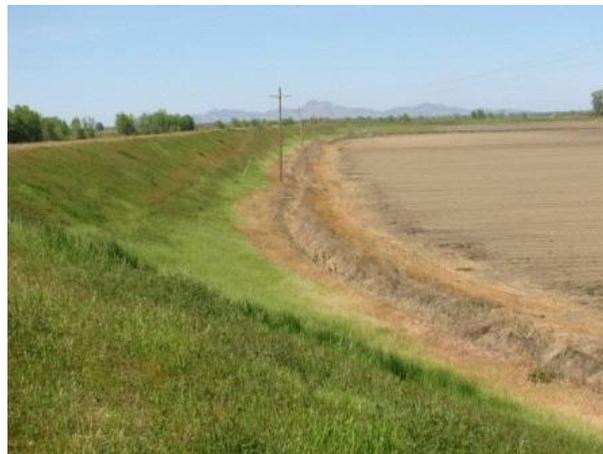
Levee Mile Report Line	87
Start Levee Mile	27.63
End Levee Mile	27.78
Location	Land Side
Category	Earthen Levee
Item	Encroachments
Agricultural ditch, photo taken in spring 2010.	
johngw_f_20130924_500.jpg

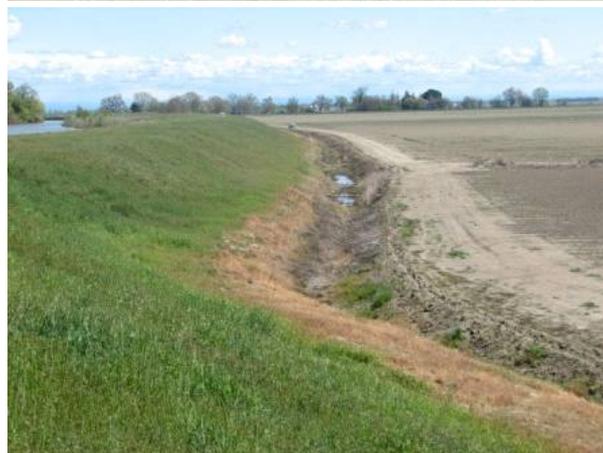
Levee Mile Report Line	88
Start Levee Mile	28.57
End Levee Mile	29.60
Location	Land Side
Category	Earthen Levee
Item	Encroachments
The agricultural ditch runs along the toe of the levee, photo taken spring 2012.	
johngw_f_20130924_414.jpg

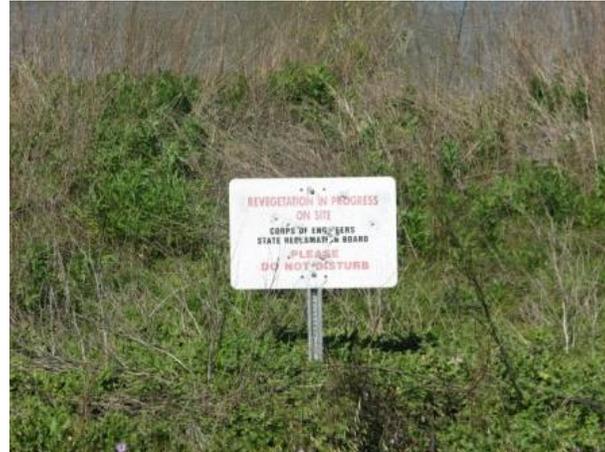
Levee Mile Report Line	89
Start Levee Mile	29.31
End Levee Mile	29.54
Location	Water Side
Category	Earthen Levee
Item	Vegetation
Another revegetation site on the waterside berm, photo taken spring 2012.	
johngw_f_20130924_473.jpg

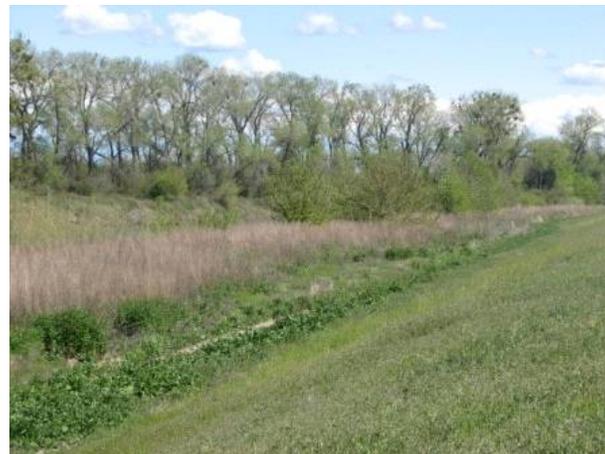
Levee Mile Report Line	89
Start Levee Mile	29.31
End Levee Mile	29.54
Location	Water Side
Category	Earthen Levee
Item	Vegetation
A photo of the revegetation site.	
johngw_f_20130924_474.jpg

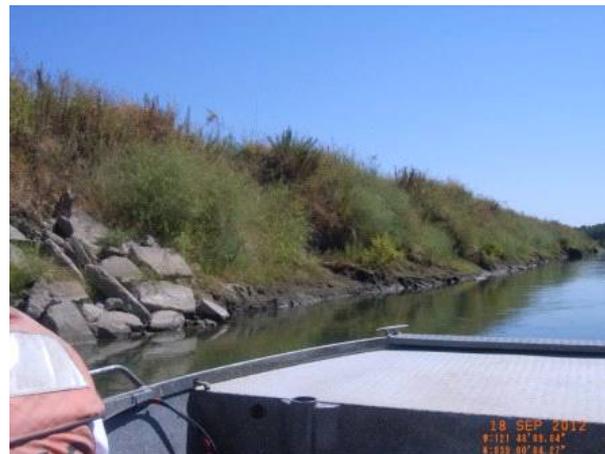
Levee Mile Report Line	91
Start Levee Mile	30.60
End Levee Mile	30.60
Location	Water Side
Category	Supplemental
Item	USACE Erosion Survey
USACE 2012 Photo #1	
USACE2013_SAC_116-0_L_1.jpg

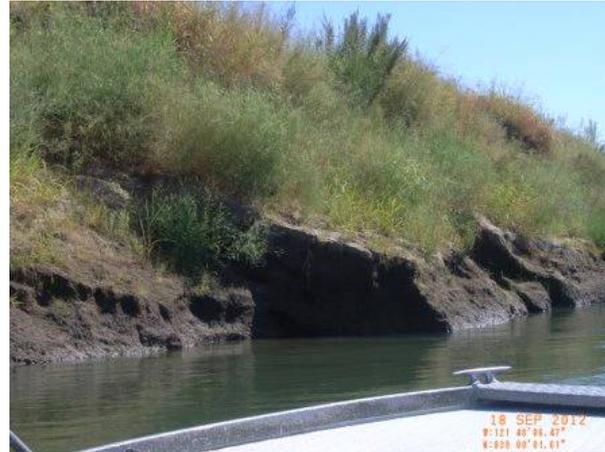
Levee Mile Report Line	91
Start Levee Mile	30.60
End Levee Mile	30.60
Location	Water Side
Category	Supplemental
Item	USACE Erosion Survey
USACE 2012 Photo #2	
USACE2013_SAC_116-0_L_2.jpg

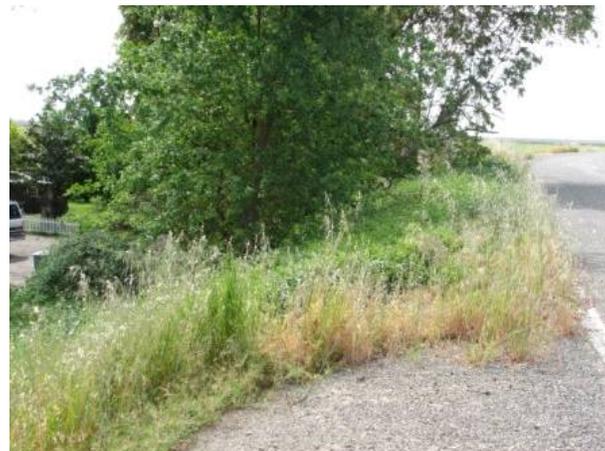
Levee Mile Report Line	92
Start Levee Mile	30.60
End Levee Mile	30.60
Location	Land Side
Category	Earthen Levee
Item	Vegetation
The groundcover in the landscape makes it hard to see the levee slope.	
johngw_f_20130924_432.jpg

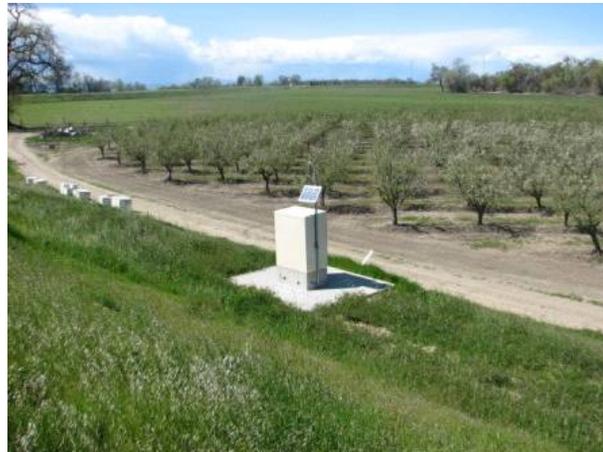
Levee Mile Report Line	95
Start Levee Mile	31.94
End Levee Mile	31.94
Location	Water Side
Category	Earthen Levee
Item	Underseepage Relief Wells
The control unit for pizometers installed in 2012, photo taken spring 2012.	
johngw_f_20130924_476.jpg

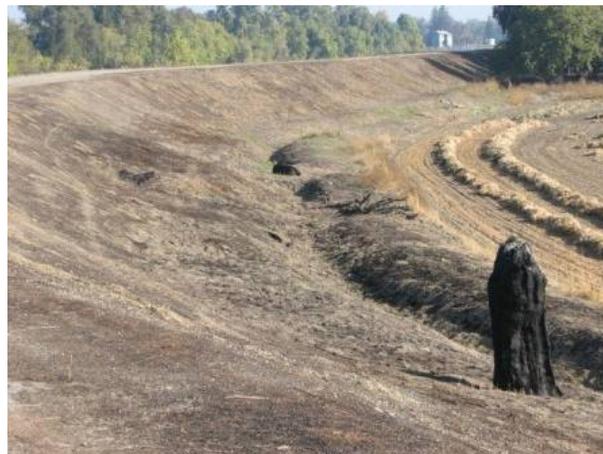
Levee Mile Report Line	96
Start Levee Mile	32.83
End Levee Mile	33.00
Location	Land Side
Category	Earthen Levee
Item	Encroachments
Older, unused agricultural ditch. Tree stump needs to be removed.	
johngw_f_20130924_450.jpg

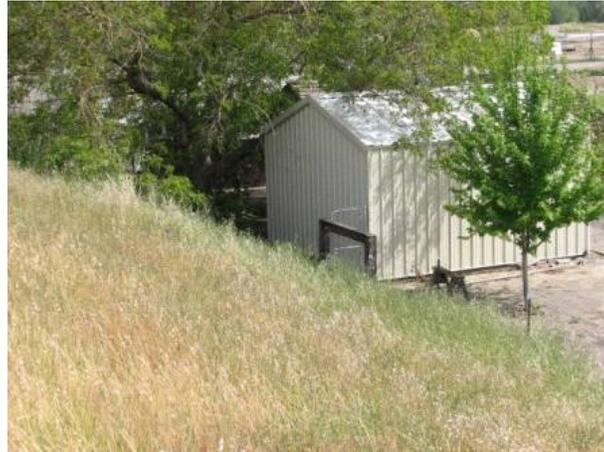
Levee Mile Report Line	97
Start Levee Mile	33.33
End Levee Mile	33.33
Location	Land Side
Category	Earthen Levee
Item	Encroachments
The building is within the easement of the levee toe.	
johngw_f_20130924_433.jpg

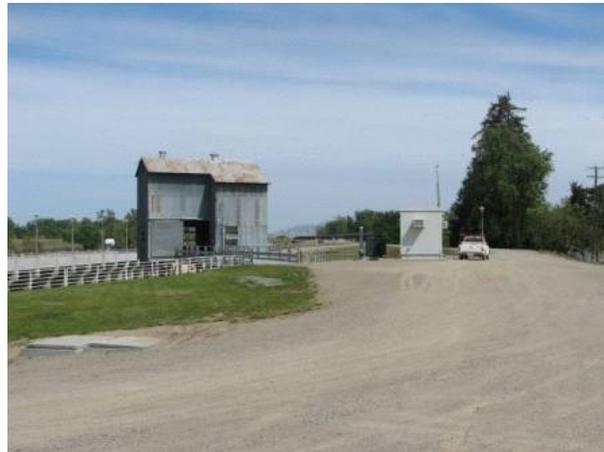
Levee Mile Report Line	98
Start Levee Mile	33.41
End Levee Mile	33.41
Location	Water Side
Category	Earthen Levee
Item	Encroachments
The buildings are on the waterside of the crown. Control buildings for the pumping plant.	
johngw_f_20130924_435.jpg

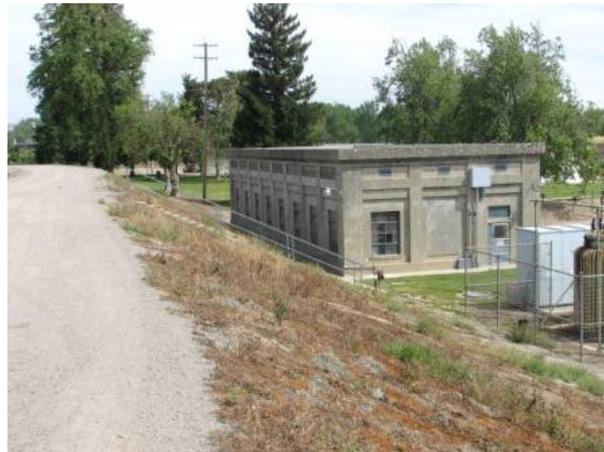
Levee Mile Report Line	99
Start Levee Mile	33.41
End Levee Mile	33.41
Location	Land Side
Category	Earthen Levee
Item	Encroachments
The building is the pumping plant for Sutter Municipal.	
johngw_f_20130924_434.jpg

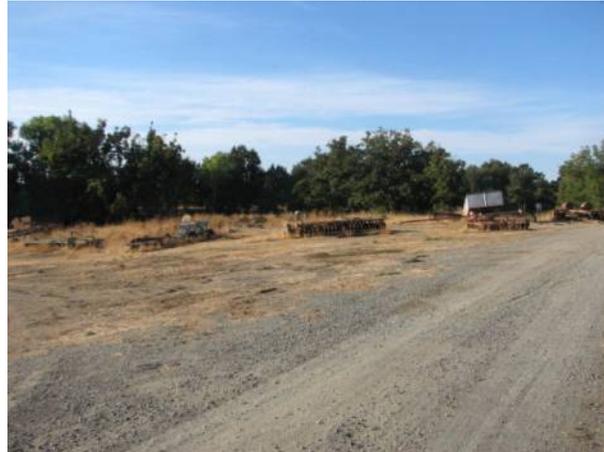
Levee Mile Report Line	1
Start Levee Mile	0.01
End Levee Mile	0.01
Location	Water Side
Category	Earthen Levee
Item	Encroachments
Farm equipment is parked on the levee slope. Photo fall 2012.	
johngw_f_20130924_512.jpg

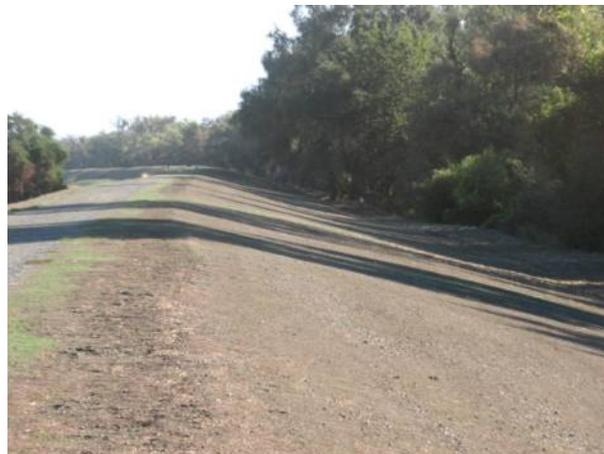
Levee Mile Report Line	2
Start Levee Mile	0.01
End Levee Mile	0.01
Location	Water Side
Category	Earthen Levee
Item	Vegetation
Waterside levee slope has been burned and dragged Fall 2013	
johngw_f_20131007_947.JPG

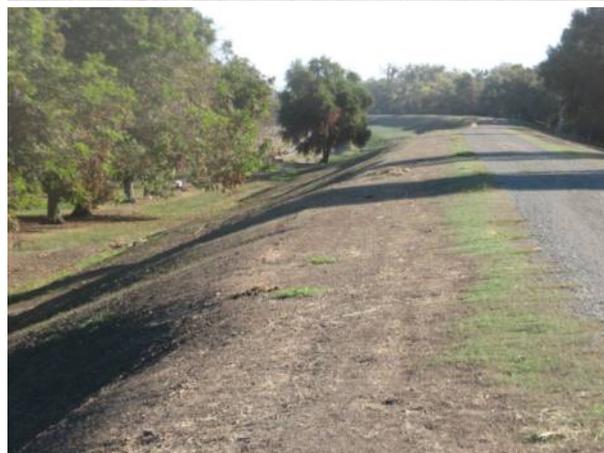
Levee Mile Report Line	3
Start Levee Mile	0.01
End Levee Mile	0.01
Location	Land Side
Category	Earthen Levee
Item	Vegetation
Landside levee slope has been burned and dragged. Fall 2013	
johngw_f_20131007_955.JPG

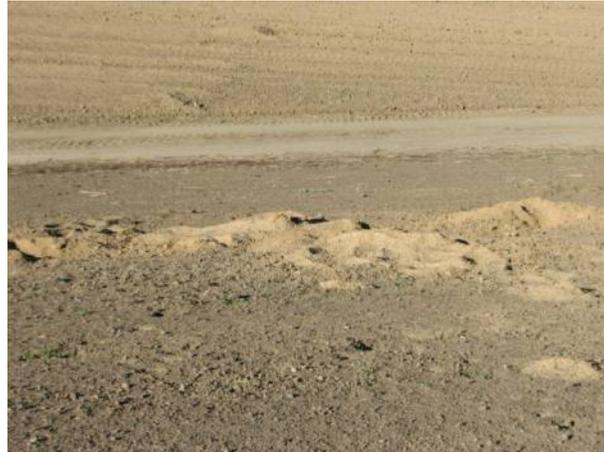
Levee Mile Report Line	5
Start Levee Mile	3.34
End Levee Mile	3.34
Location	Land Side
Category	Earthen Levee
Item	Animal Control
Rodent hole on the landside levee toe. Fall 2013	
johngw_f_20131007_948.JPG

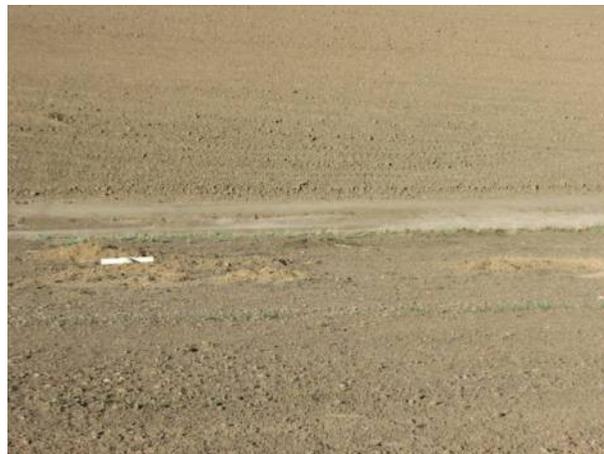
Levee Mile Report Line	6
Start Levee Mile	3.42
End Levee Mile	3.42
Location	Land Side
Category	Earthen Levee
Item	Animal Control
Rodent hole on the landside toe. A bait station is close by. Fall 2013	
johngw_f_20131007_949.JPG

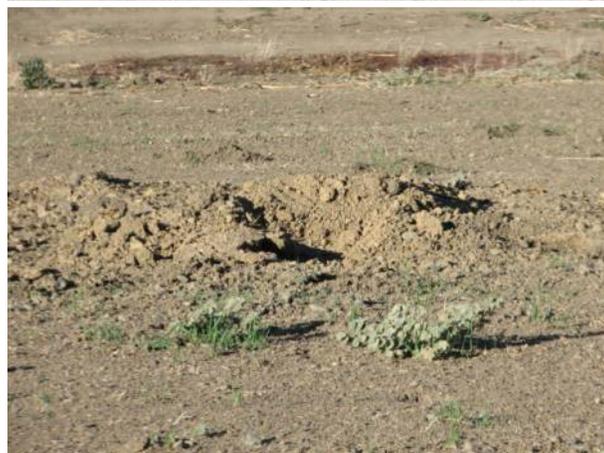
Levee Mile Report Line	7
Start Levee Mile	3.98
End Levee Mile	3.98
Location	Land Side
Category	Earthen Levee
Item	Animal Control
A large rodent hole on the landside levee slope. Fall 2013	
johngw_f_20131007_950.JPG

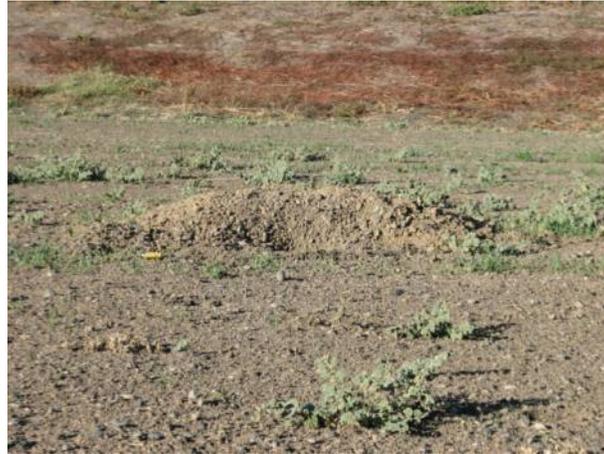
Levee Mile Report Line	8
Start Levee Mile	4.16
End Levee Mile	4.16
Location	Land Side
Category	Earthen Levee
Item	Animal Control
A rodent hole on the landside levee slope. Fall 2013	
johngw_f_20131007_951.JPG

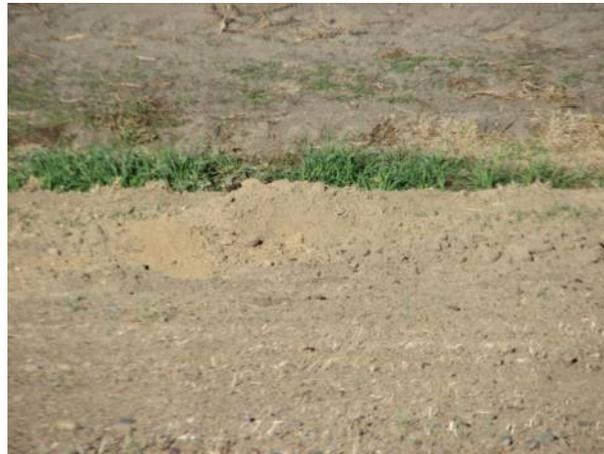
Levee Mile Report Line	9
Start Levee Mile	6.23
End Levee Mile	6.23
Location	Land Side
Category	Earthen Levee
Item	Animal Control
A rodent hole at the toe. Fall 2013	
johngw_f_20131007_952.JPG

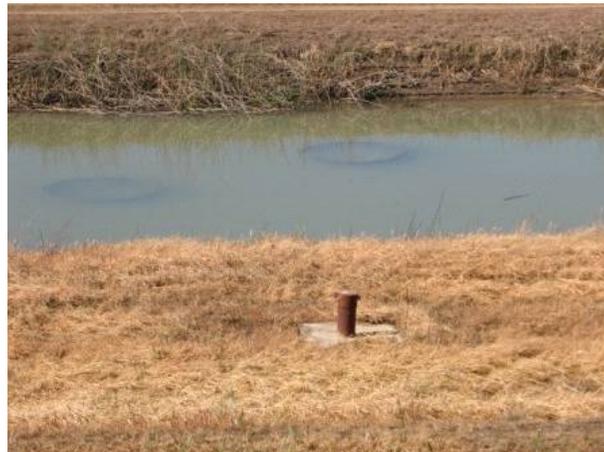
Levee Mile Report Line	11
Start Levee Mile	14.22
End Levee Mile	14.22
Location	Land Side
Category	Earthen Levee
Item	Underseepage Relief Wells
The relief well at boil 12, photo taken spring 2012.	
johngw_f_20130924_504.jpg

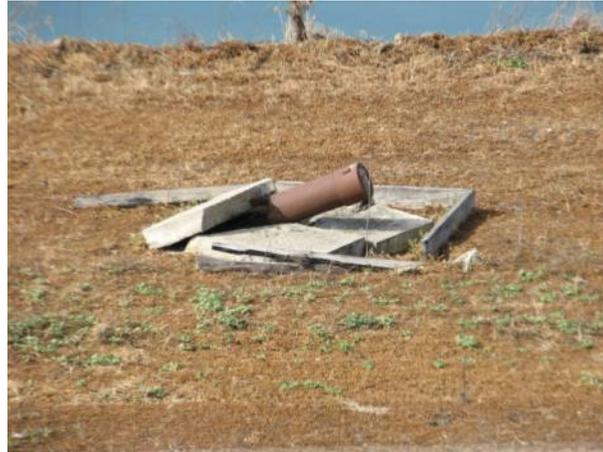
Levee Mile Report Line	12
Start Levee Mile	14.40
End Levee Mile	14.40
Location	Land Side
Category	Earthen Levee
Item	Underseepage Relief Wells
The seepage well and pad needs to be repaired, Spring 2013	
johngw_f_20130924_510.JPG

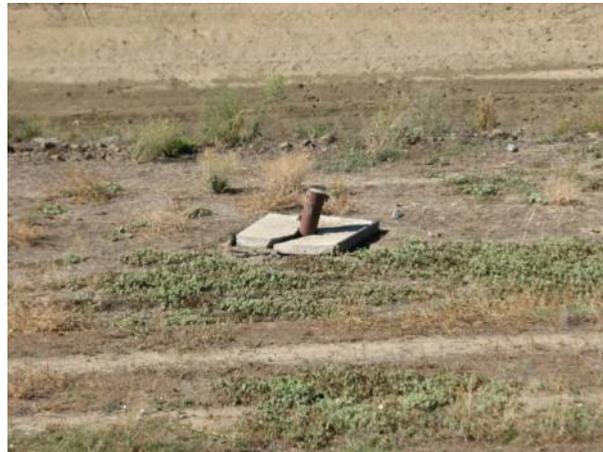
Levee Mile Report Line	12
Start Levee Mile	14.40
End Levee Mile	14.40
Location	Land Side
Category	Earthen Levee
Item	Underseepage Relief Wells
The pieces of the puzzle have been placed back. Unsure if repaired. Fall 2013	
johngw_f_20131007_953.JPG

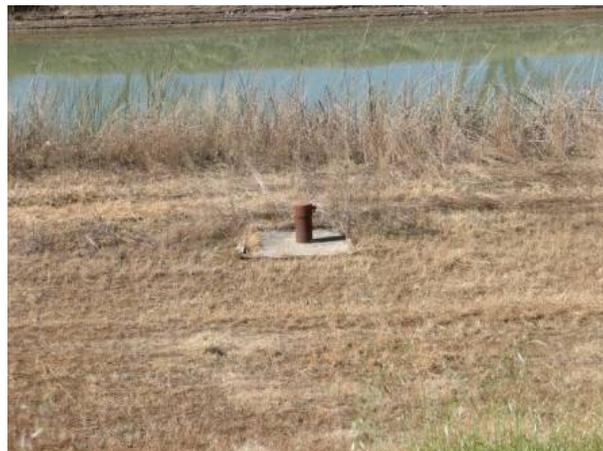
Levee Mile Report Line	13
Start Levee Mile	14.56
End Levee Mile	14.56
Location	Land Side
Category	Earthen Levee
Item	Underseepage Relief Wells
A relief well at boil 16, photo taken spring 2012.	
johngw_f_20130924_511.jpg

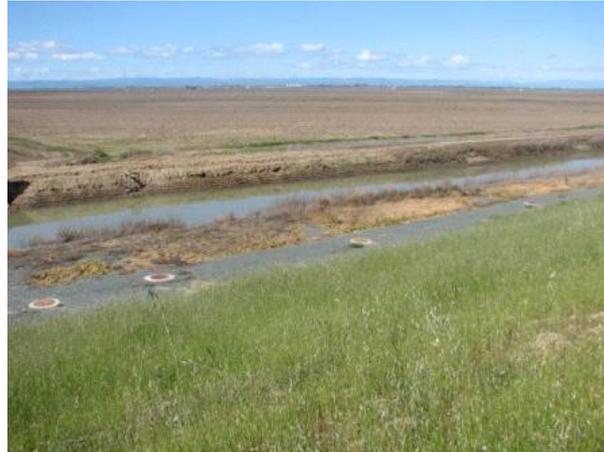
Levee Mile Report Line	19
Start Levee Mile	18.24
End Levee Mile	18.24
Location	Land Side
Category	Earthen Levee
Item	Underseepage Relief Wells
Toe drainage systems along the toe berm four total, photo taken spring 2012.	
johngw_f_20130924_513.jpg

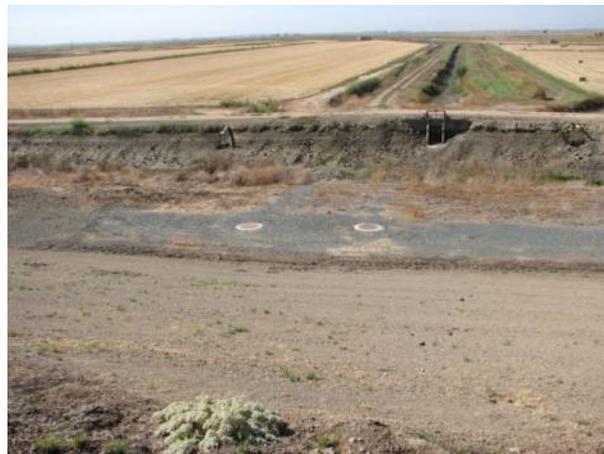
Levee Mile Report Line	19
Start Levee Mile	18.24
End Levee Mile	18.24
Location	Land Side
Category	Earthen Levee
Item	Underseepage Relief Wells
Two of five drains on the landside berm. Photo fall 2012.	
johngw_f_20130924_514.jpg

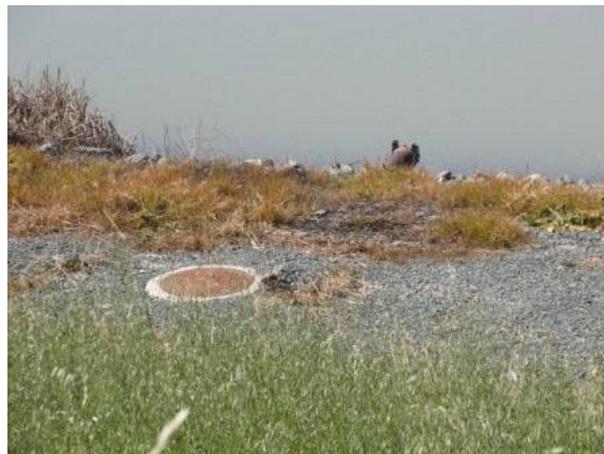
Levee Mile Report Line	20
Start Levee Mile	18.48
End Levee Mile	18.48
Location	Land Side
Category	Earthen Levee
Item	Underseepage Relief Wells
A toe drainage system at the toe berm, photo taken spring 2012.	
johngw_f_20130924_516.jpg

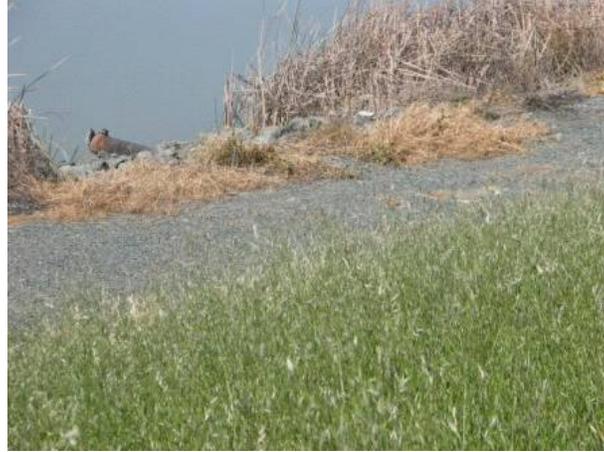
Levee Mile Report Line	20
Start Levee Mile	18.48
End Levee Mile	18.48
Location	Land Side
Category	Earthen Levee
Item	Underseepage Relief Wells
Another toe drainage system close by, photo taken spring 2012.	
johngw_f_20130924_517.jpg
